The Great Socorro Hail Storm • October 5, 2004 • 2–3 p.m.

Socorro, NM was struck with a devastating hailstorm on Oct. 5, 2004 with hail clearly larger than a golf ball to nearly baseball in size. Damage estimates are "in the millions." The area around the New Mexico Tech campus and the NRAO Array Operations Center (AOC) seems to be the hardest hit. At the AOC, about 80% of the employee's cars in the parking lot suffered severe damage – from major denting and pelting from the hailstones, to completely destroyed windows. Many cars had to be towed out of the lot.

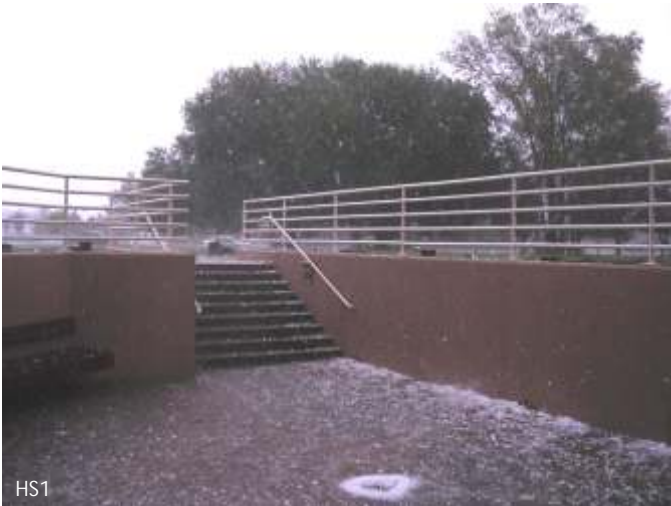
HS1
The onset of the storm about 2 p.m., looking east from the AOC first-floor patio area. Marble-sized hail fell for the first few minutes, growing to golf ball sized.

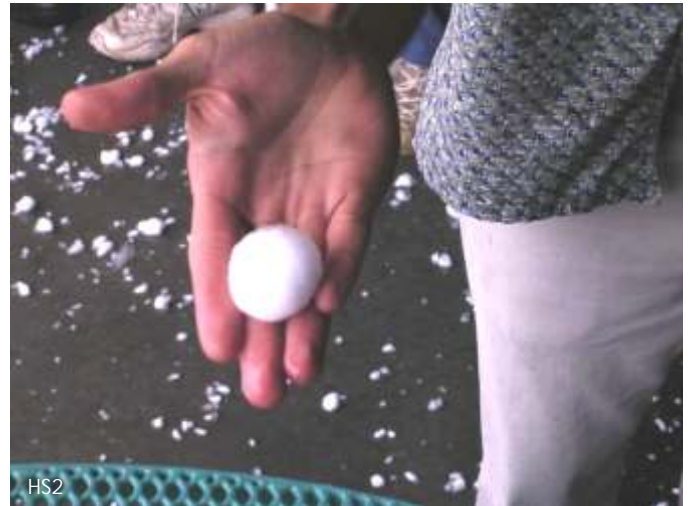
HS2
One of the golf ball sized hailstones at the beginning of the storm.

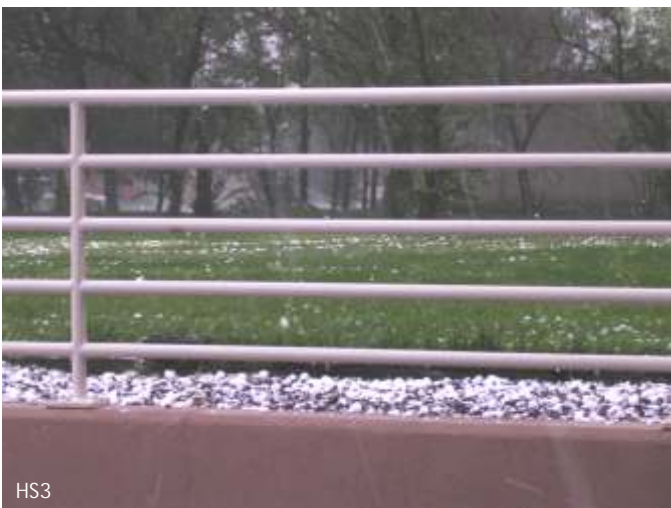
HS3
The view across the AOC lawn as the golf-ball sized hail began. The hailstones would bounce several feet in the air after hitting the grass.

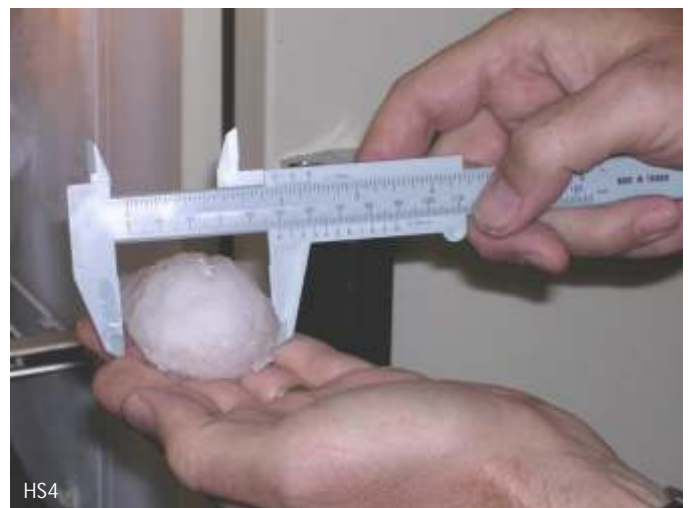
HS4
A hailstone captured about midway through the storm. This one measures 50mm., or 2 inches. After the storm, stones from 2.5–3.0 inches were found on the ground. Note the larger hailstones were nearly solid ice. The storm persisted about 45 minutes.

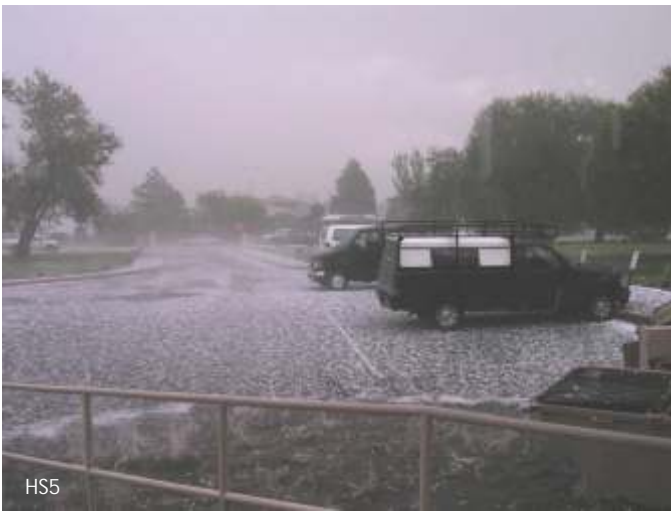
The view from the AOC "back door" by the receiving dock, looking east, when the heavy hail began falling. These NRAO vehicles were damaged.

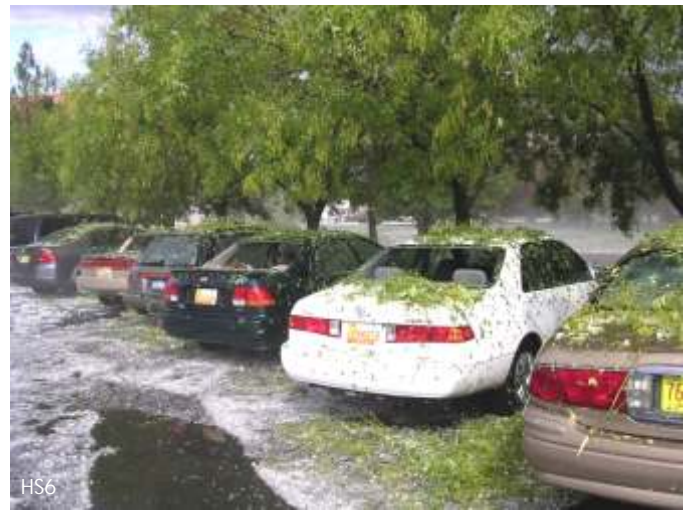
A small part of the AOC parking lot after the storm. All vehicles suffered heavy dent damage and most had severe window damage. Many of the cars (3 shown here) had their rear windows completely blown out from the hail damage.

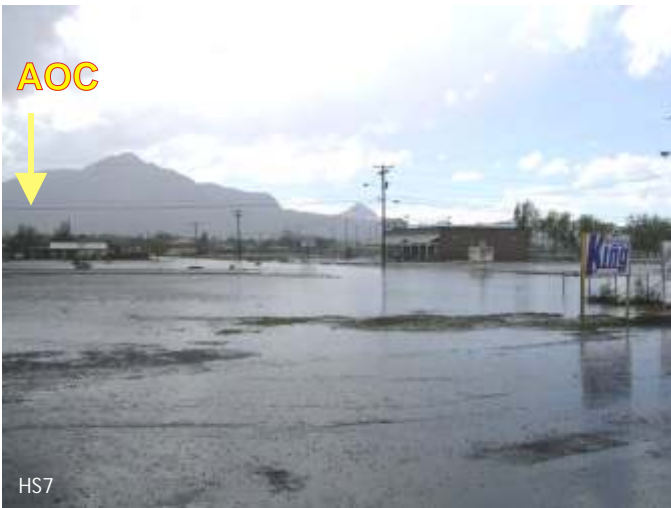
Following the storm, electricity & phones were out. This is some of the flooding facing NRAO employees trying to get home. Bullock Ave. west of California St. (shown here) was closed by the police.

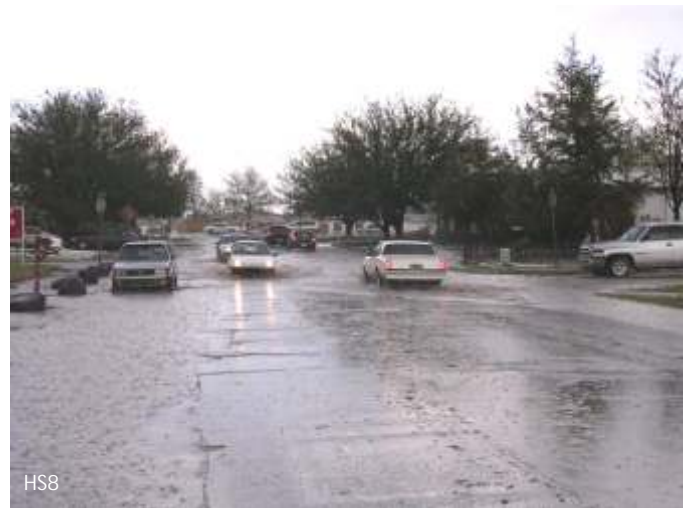
An alternative route from Bullock Ave. – Franklin Street – was not much better!

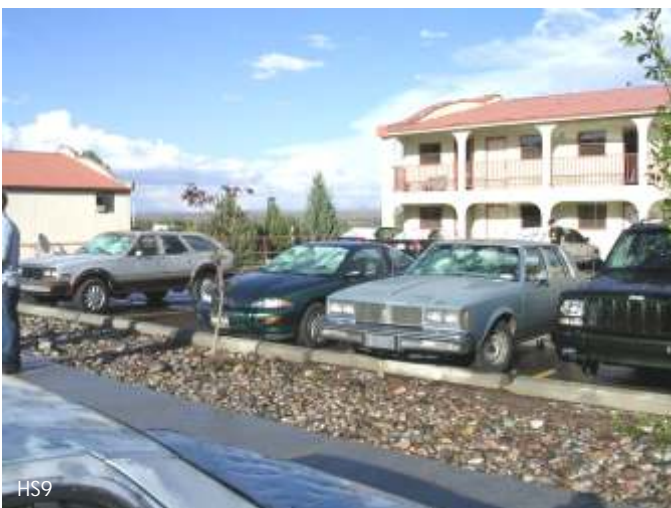
Damaged vehicles at the dorms, New Mexico Tech, about 1/2 mile SE of the AOC. Note heavy denting and destroyed windshields.

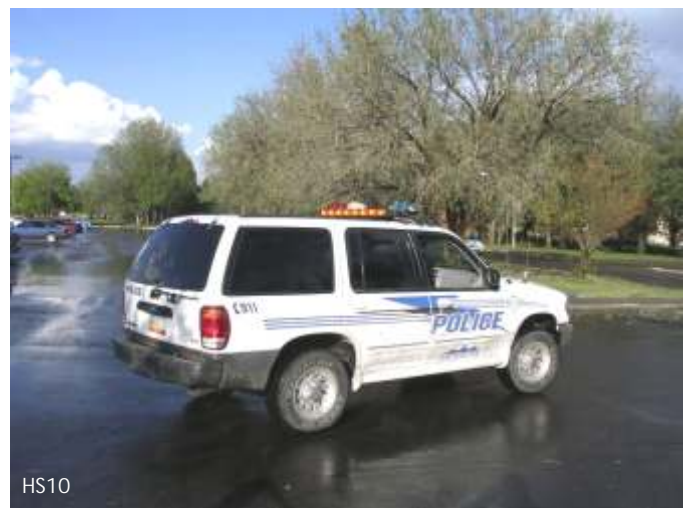
Even the "cops" didn't escape the storm. NMT Police unit was damaged – emergency lights on top busted off, no passenger window, heavily busted windshield.

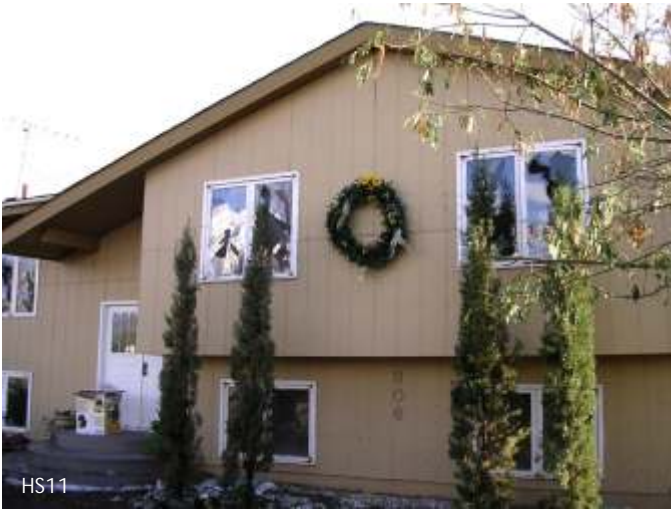
Typical house damage. Many north and west facing windows were broken. The hailstones passed through the triple-paned windows on this home.

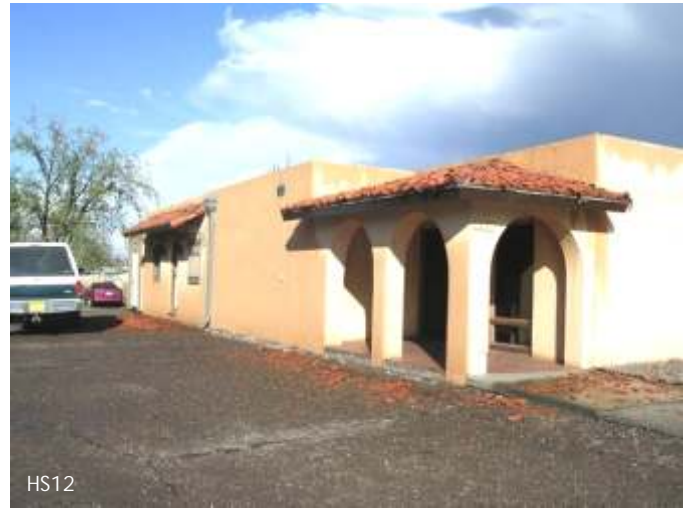
Homes and buildings with tile roofing were severely damaged – this is a local dentist's office about a mile southwest of the AOC.
