## **TEST AND VERIFICATION REPORT**

### **HM Gbps End-to-End Test Results and Design Recommendations**

TVR Document: **A25022N0044**

*National Research Council Canada  
Herzberg Institute of Astrophysics  
Dominion Radio Astrophysical Observatory*

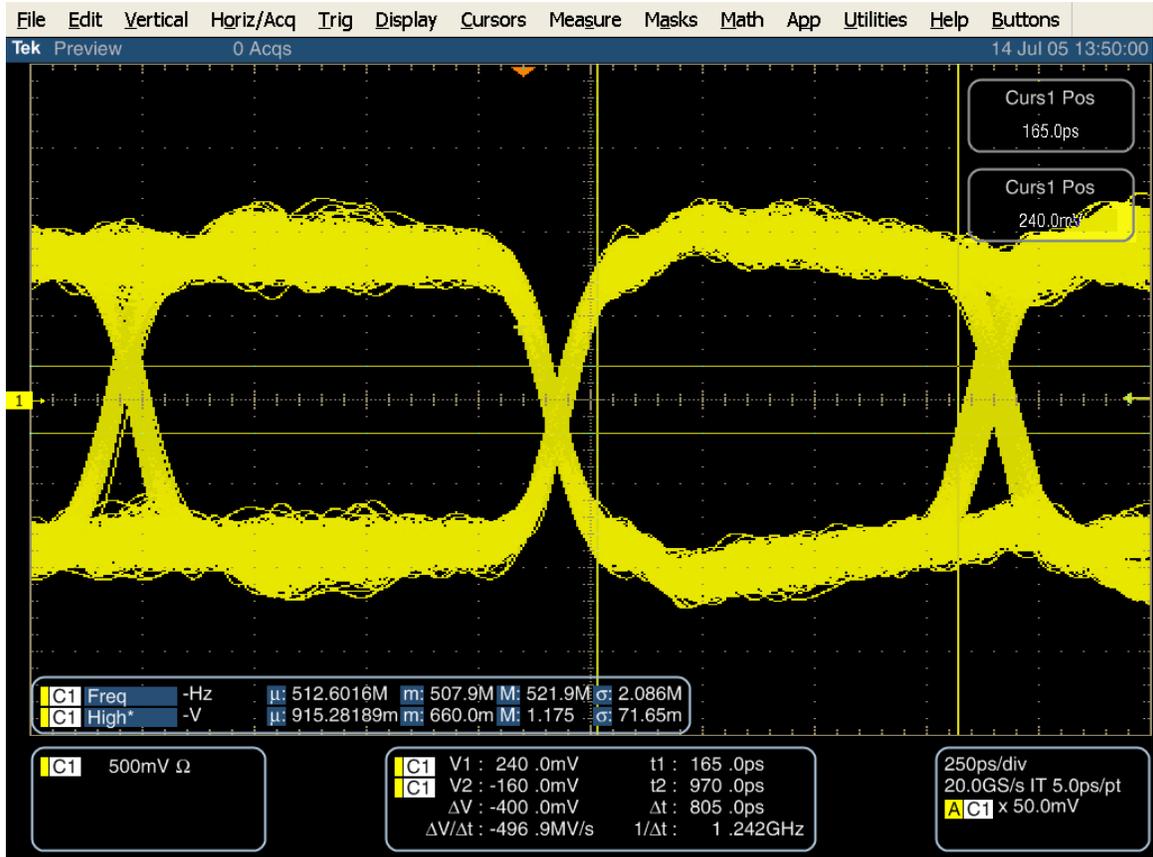
**Figure 5 Transmitter—1 m cable—100 cable termination.** This eye diagram demonstrates that the transmitter, through the connector, the backplane, and through 1 m of cable operates very well. The eye opening is about 800 psec. For this test, 100 ohm radial-lead termination resistors were plugged into the end of the cable. The signal was measured at the termination resistors with 1 wafer of signals active.

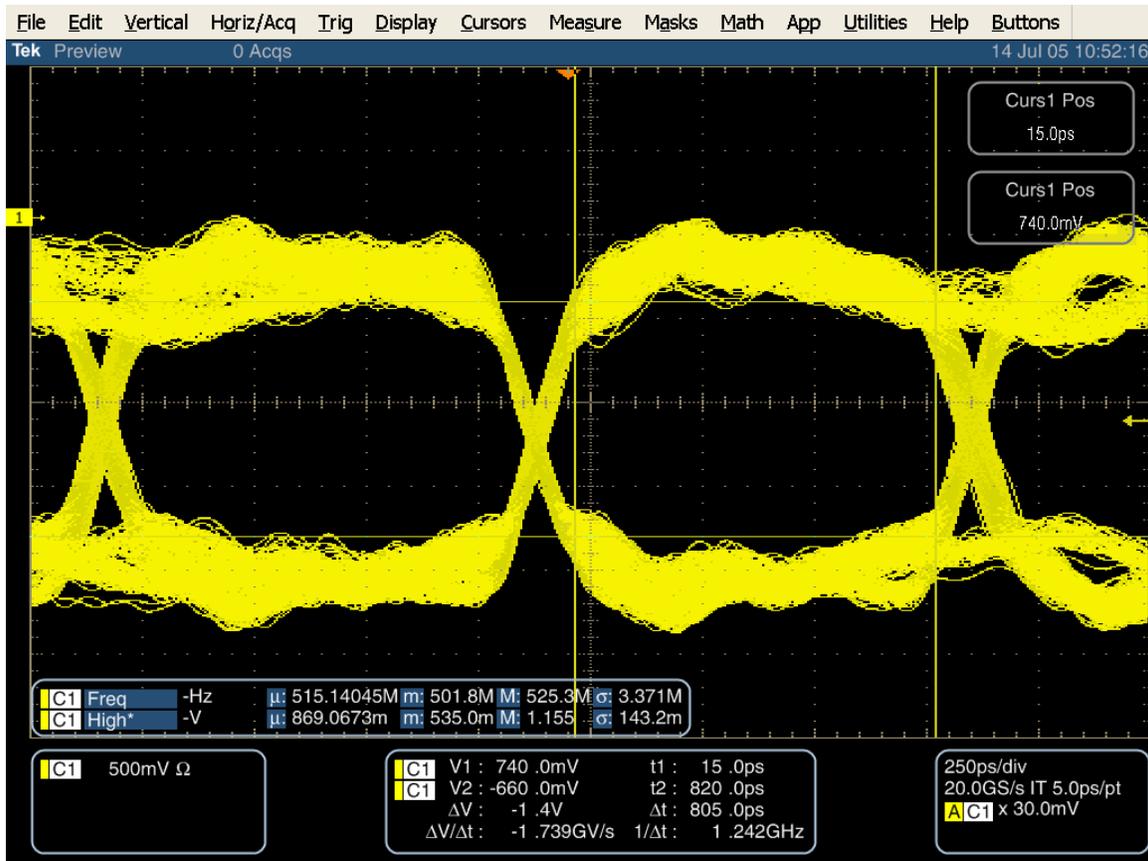
**Figure 6 Transmitter—1m cable—backplane—connector—100 ohm termination. For this test, a backplane and right-angle hard-metric connector at the far end were used. 100 ohm termination resistors were soldered on the connector tails for 2 active adjacent wafers. The connector was not press-fit into a circuit board. This test shows some, but not significant, signal degradation over the previous figure. It indicates that there is some degradation going through the connector and backplane at the far end, but it is not significant.**
