# Correlator Power Monitor Control System

*B. Carlson*

## Outline

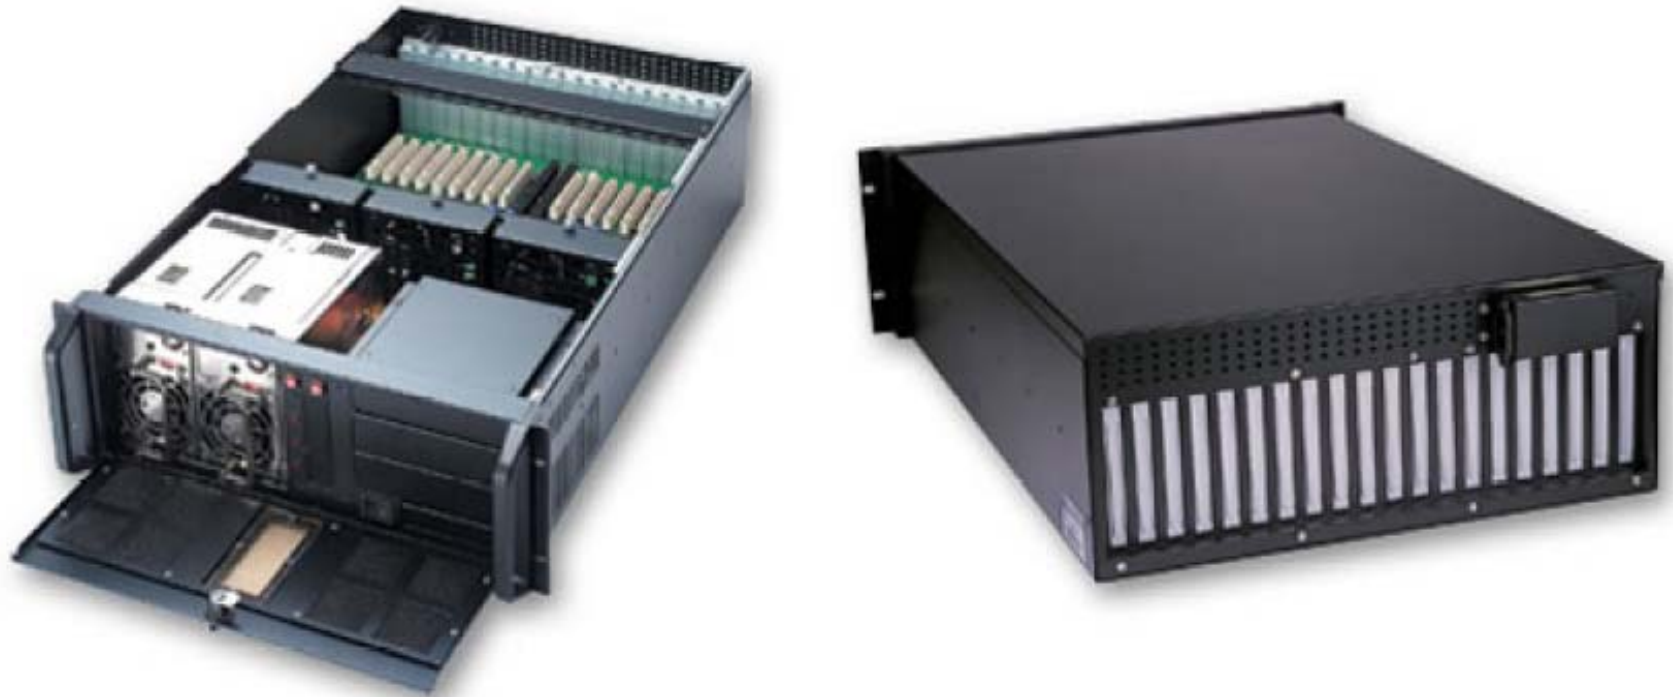
## FMEA of redundant Control Racks:

<b>Failure</b>	<b>Effect</b>	<b>Action Required/Taken</b>
Fan control opto-coupler fails (CE open)	Fan runs at full speed. Fan speed monitor indicates full speed.	Maintenance day debug to find problem. Could be RPMIB, cable, or NI 6509.
Fan speed monitor opto-coupler fails	CPCC senses that fan has quit. Redundant CPCC sees that fan is ok. No manual inspection required.	Maintenance day the RPMIB, cable, or NI 6509 need checking and possible replacement.
Correlator board power control line fails/disconnects	Correlator module continues to run, and no immediate indication of failure condition.	Maintenance day check finds problem. Debug to determine if RPMIB, cable, or NI 6509 failure.
Correlator board power monitor line fails	Indication is that power on the module is off. Redundant CPCC sees its ok, and CMIB responds.	Maintenance day debug required to determine if it is the RPMIB, cable, or NI 6509 card.

-48 V monitor line fails	Indication is that -48 VDC has failed. Redundant CPCC says ok. Fan speed is still ok, CMIBs responding <sup>3</sup> . Conclude that monitor line has failed.	Maintenance day debug required to determine if it is the RPMIB, cable, or NI 6509.

5-bit ID changes	No operational effect. Redundant CPCC sees same problem. Software must be designed to be robust to this failure.	Manual debug required to determine if it is the RPMIB, cable, or NI 6509.
SCSI-100 cable connector comes loose.	Fans may run at full speed. Correlator boards continue to run. Indication is that one or more fans have quit and that one or more modules have quit. -48 VDC monitor could indicate -48 VDC power lost. Redundant CPCC says everything is ok, but fans are running too fast.	Maintenance day debug required to determine if RPMIB has massively failed, cable is bad/disconnected, or NI 6509 card is dead. No lost correlator time.
NI 6509 card PCI bus interface fails.	Rack keeps running ok. Indication is that rack is experiencing multiple failures. Redundant CPCC says everything ok. Power control may be lost <sup>4</sup> .	Maintenance day debug to determine problem. Requires power-cycle of affected CPCC to replace NI 6509 card. No correlator interruption.

CPCC CPU fails.	Auto-reboot may or may not restore CPCC. NI 6509 "safe mode" is all control outputs hi-Z. All racks continue to operate normally, all fans at full speed. Full monitor and control provided by redundant CPCC.	Manual debug to find problem...continuous reboot cycles of the processor reasonably quickly diagnosed. Requires defective CPCC power down and CPU replacement. No lost correlator time.
CPCC power supply fails.	Redundant CPCC provides M&C functions. Correlator remains on-line.	Replace defective power supply or entire unit the next day to bring failed CPCC back on line. No lost correlator time.
